THE BENGAL GOVERNMENT.

PAPERS OF 1853 AND 1854

DAMOODAH EMBANKMENTS, &c, &c, &c

DAMOODAH EMBANKMENTS,

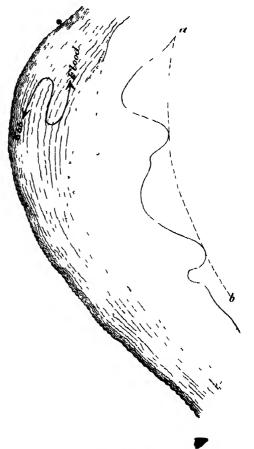
The present Section is No. 66 to be increased to No 67, which was taken from a portion of about 100 feet executed, and which is the only spot on which any work was found in progress between Musraka and the Hooghly. They were not executing the work according to orders in layers, to be consolidated as the work proceeds, but throwing it loosely from top of old Section, whilst the temporary Sections erected differed in level as much as 1'7" in 100

yards. The old or present line is much breached, and though I could get no account of the rise of the flood from either Overseer or Darogah, both new men, (and the villager's report is not to be trusted) the appear-

ance of the crest and inner slope warrants the supposition that the water has gone over them. Reeds and quantity of jungle on the embankments.

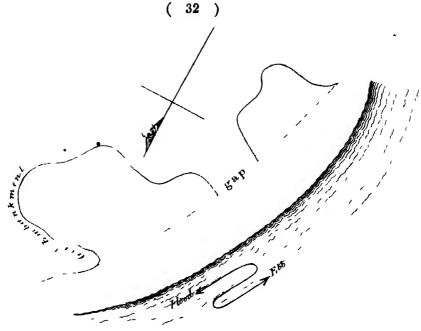
63. Government line from the Toltolah Khal was repaired last year in an indifferent manner, and half a mile South is a new line constructed last year, but which has been joined to the old line at so sharp an angle and in so awkward a direction, that it must be relaid out at both ends, and the Section, No 82, not sufficient on outer slope, nor high enough, must be strengthened again. I have before remarked on the want of management, by which embankments require additions two years successively. At the end of this newly-made line, the old one stretches away into the country in an extraordinary way, for nearly a mile, and ends abruptly at right angles to the river; there is then a gap, and the line recommences with another wandering course, the whole being useless, and it is a matter of much surprise how the embankments could have been allowed to remain in this state so long, for there is no high ground or any other reason why this gap should have existed, nor why the line has been permitted and repaired in this state.

A new and better line is projected for this season as shown in red, two and a half miles South of Gwalapotah, Government line repaired last year in patches as per Section No. 83. The turfing is very bad indeed, the crest is uneven and much cracked, the work must have been loosely and carclessly performed The unrepaired portions are 15 inches below those repaired, and sometimes more, presenting an appearance thus.—
